RE: AZS Chemical Company (a.k.a. Cargill)
Atlanta, Fulton County, Georgia
Preliminary Assessment Report

**PRELIMINARY ASSESSMENT
AZS CHEMICAL CO. (a.k.a. CARGILL)
762 MARIETTA BLVD. N.W.
ATLANTA, FULTON COUNTY, GEORGIA
EPA ID #s GAD981237225 & GAD057288144**

Photo	1 of 45	Date:	09/24/2007	Site Name:	AZS Corporation		
Photographer:	Thomas J Brodell, QEP; HWMB			City:	Atlanta	County:	Fulton
Explanation:	MW-1, the designated background well. Currently used as a bathroom facility by indigents living on property as indicated by partially decomposed toilet paper around well. Well found unlocked.

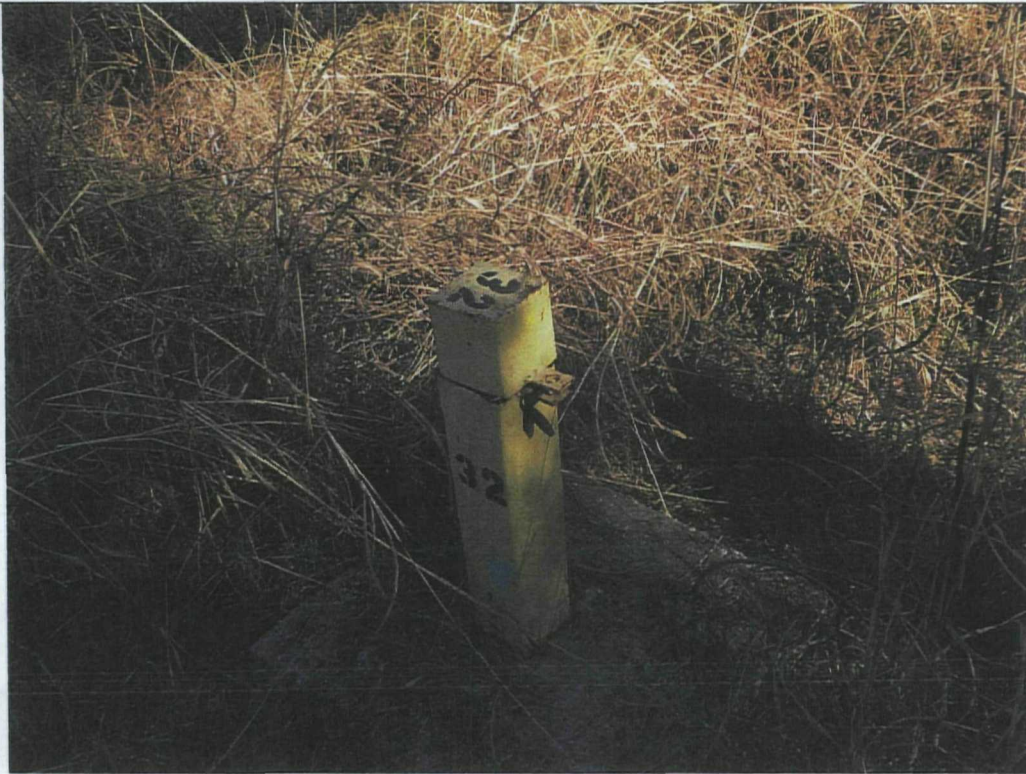
Photo	33 of 43	Date:	11/29/07	Site Name:	AZS Corporation		
Photographer:	Thomas J Brodell, QEP; HWMB			City:	Atlanta	County:	Fulton
Explanation:	Rusted, open lock hanging on well casing for MW-32.

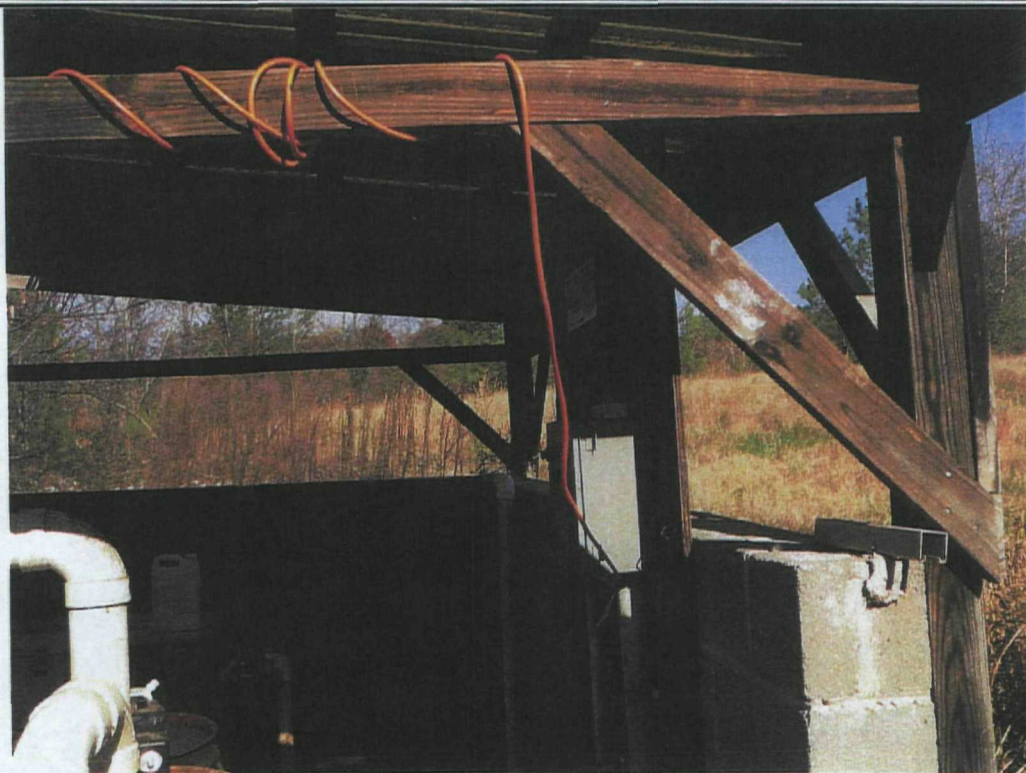
Photo	34 of 43	Date:	11/29/07	Site Name:	AZS Corporation		
Photographer:	Thomas J Brodell, QEP; HWMB			City:	Atlanta	County:	Fulton
Explanation:	Groundwater treatment system found operational. Orange extension cord used to supply electricity to sump pump for area within the shed.

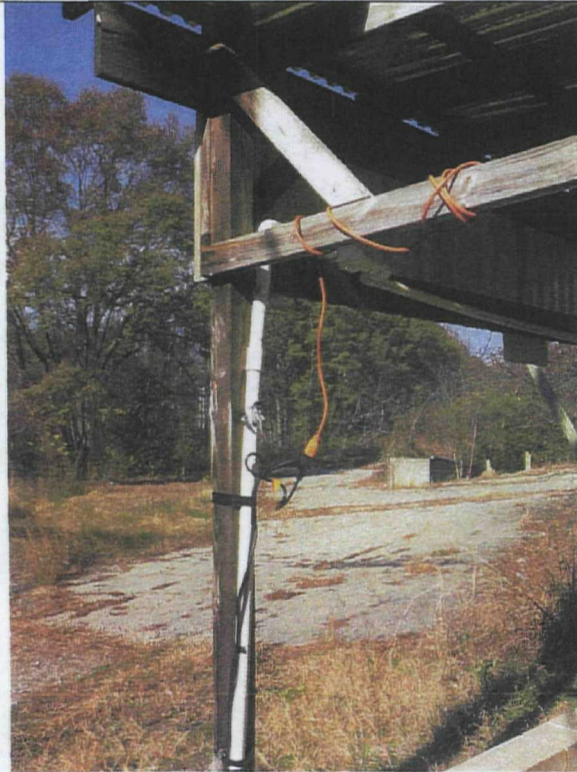
Photo	35 of 43	Date:	11/29/07	Site Name:	AZS Corporation		
Photographer:	Thomas J Brodell, QEP; HWMB			City:	Atlanta	County:	Fulton
Explanation:	Groundwater treatment system found operational. Orange extension cord used to supply electricity to sump pump for area within the shed.

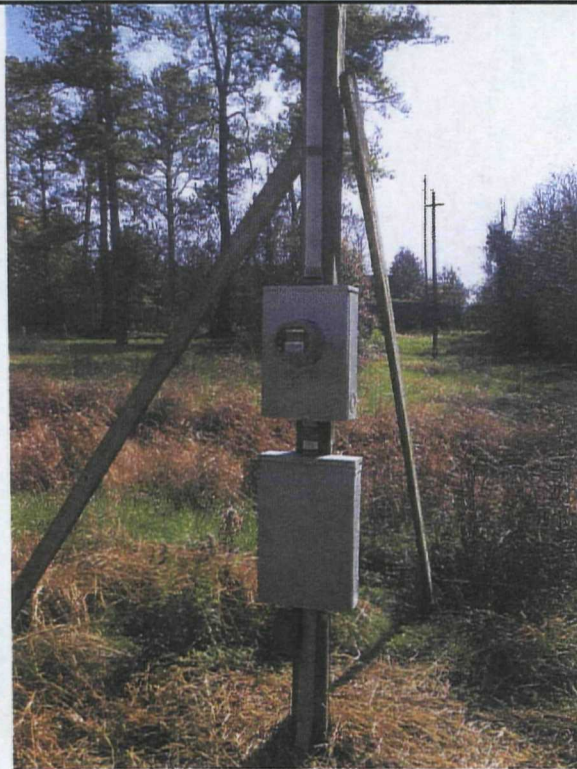
Photo	36 of 43	Date:	11/29/07	Site Name:	AZS Corporation		
Photographer:	Thomas J Brodell, QEP; HWMB			City:	Atlanta	County:	Fulton
Explanation:	Electrical meter and panel repaired and in operation. Electrical devices pictured here were observed to be stripped of copper during 2007 CEI.

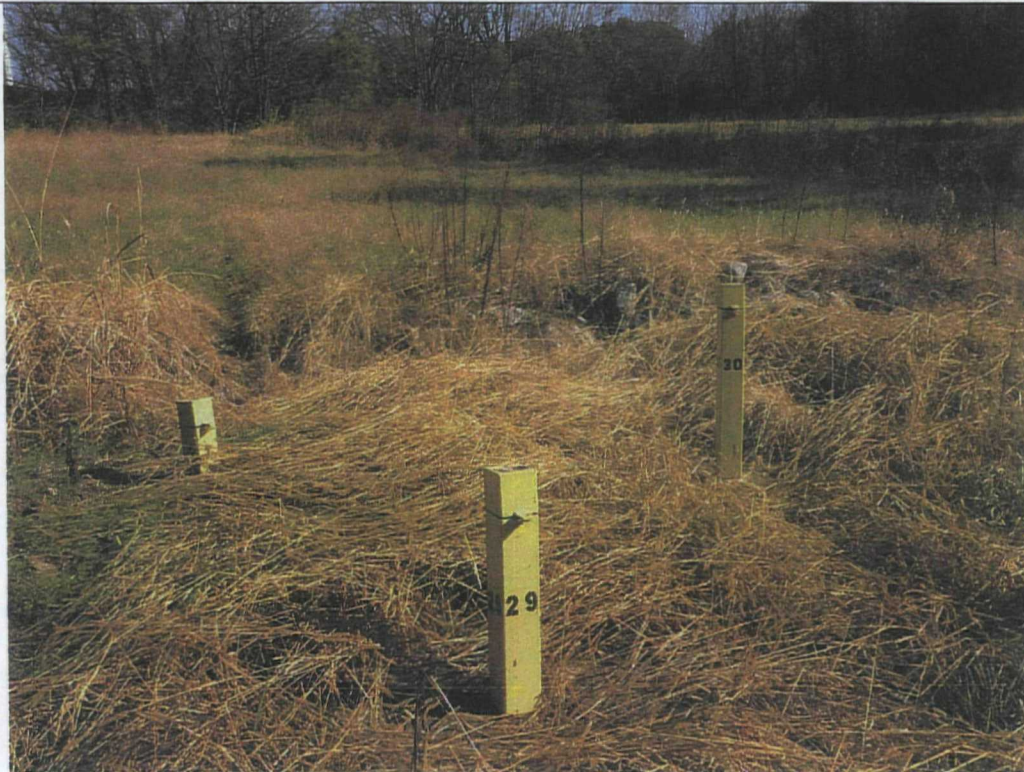
Photo	37 of 43	Date:	11/29/07	Site Name:	AZS Corporation		
Photographer:	Thomas J Brodell, QEP; HWMB			City:	Atlanta	County:	Fulton
Explanation:	From left to right: MW-7, MW-29 and MW-30, all observed without locks. The Cap for the Series Pond is visible beyond the riprap in the middle of the photo.

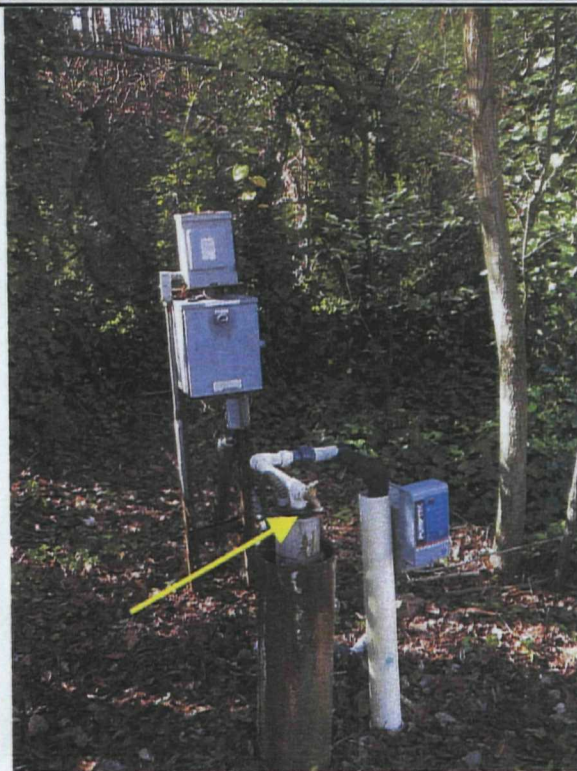
Photo	38 of 43	Date:	11/29/07	Site Name:	AZS Corporation		
Photographer:	Thomas J Brodell, QEP; HWMB			City:	Atlanta	County:	Fulton
Explanation:	RW-4, newly repaired electrical and piping. Electrical panel and switch in background no longer functional. Arrow points to new non-lockable spigot installed on system piping, and found to be capable of delivering water when opened.

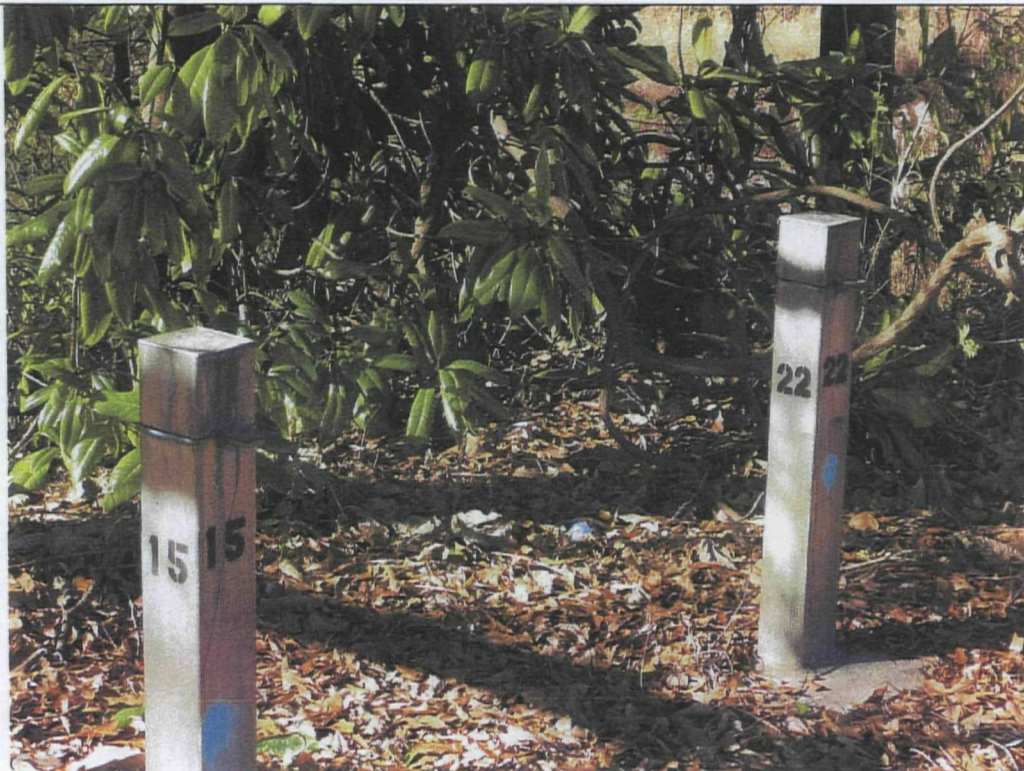
Photo	39 of 43	Date:	11/29/07	Site Name:	AZS Corporation		
Photographer:	Thomas J Brodell, QEP; HWMB			City:	Atlanta	County:	Fulton
Explanation:	MW-15 and MW-22, both observed without locks

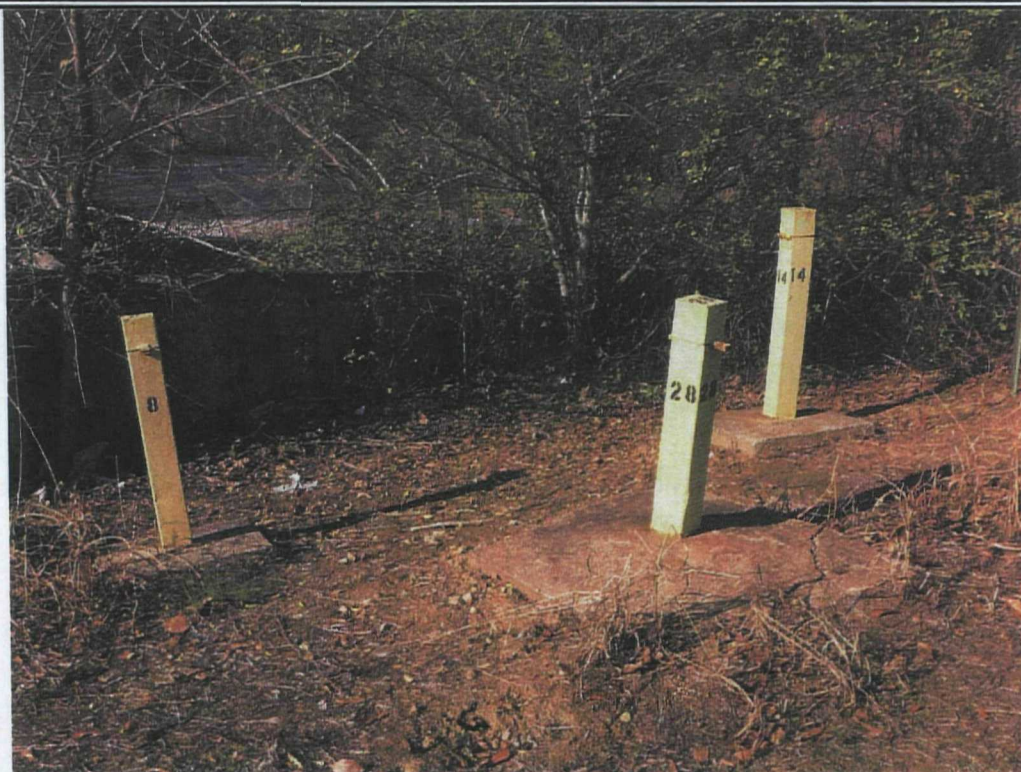
Photo	40 of 43	Date:	11/29/07	Site Name:	AZS Corporation		
Photographer:	Thomas J Brodell, QEP; HWMB			City:	Atlanta	County:	Fulton
Explanation:	MW-8, MW-28 and MW-14, all observed without locks

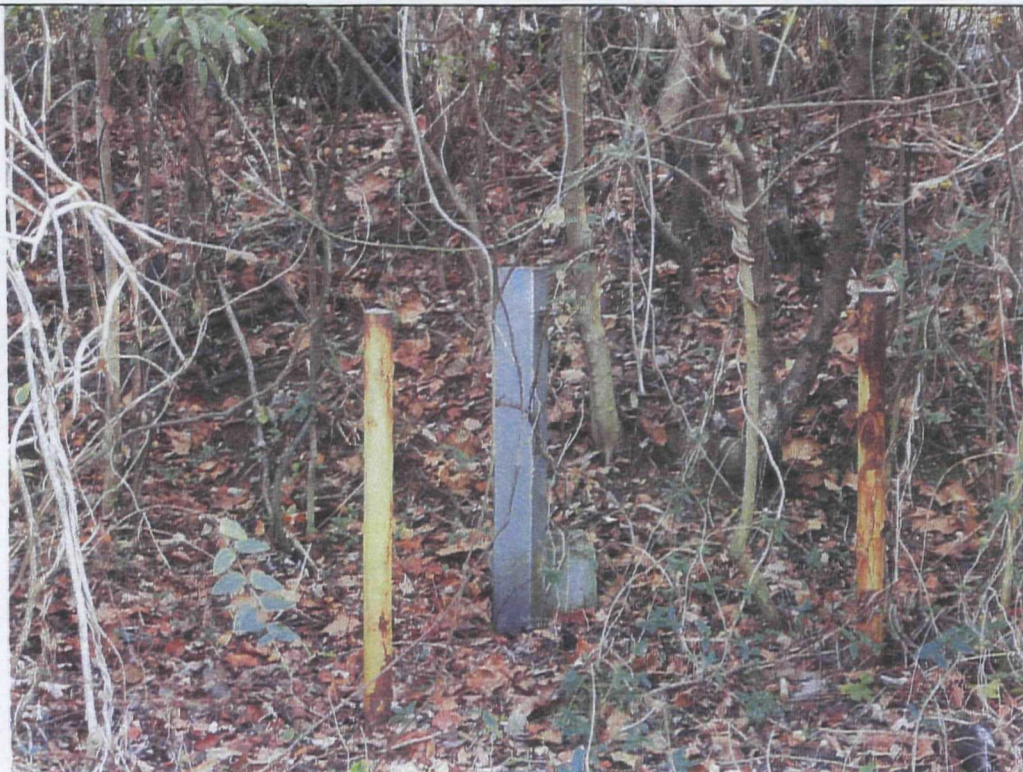
Photo	41 of 43	Date:	11/29/07	Site Name:	AZS Corporation		
Photographer:	Thomas J Brodell, QEP; HWMB			City:	Atlanta	County:	Fulton
Explanation:	Unlabeled well found in southeast corner of property, near former gate to finishing plant. Well was not observed during 2007 CEI. Well is locked.					GPS:	Lat: 33.77443 Long: -84.42686

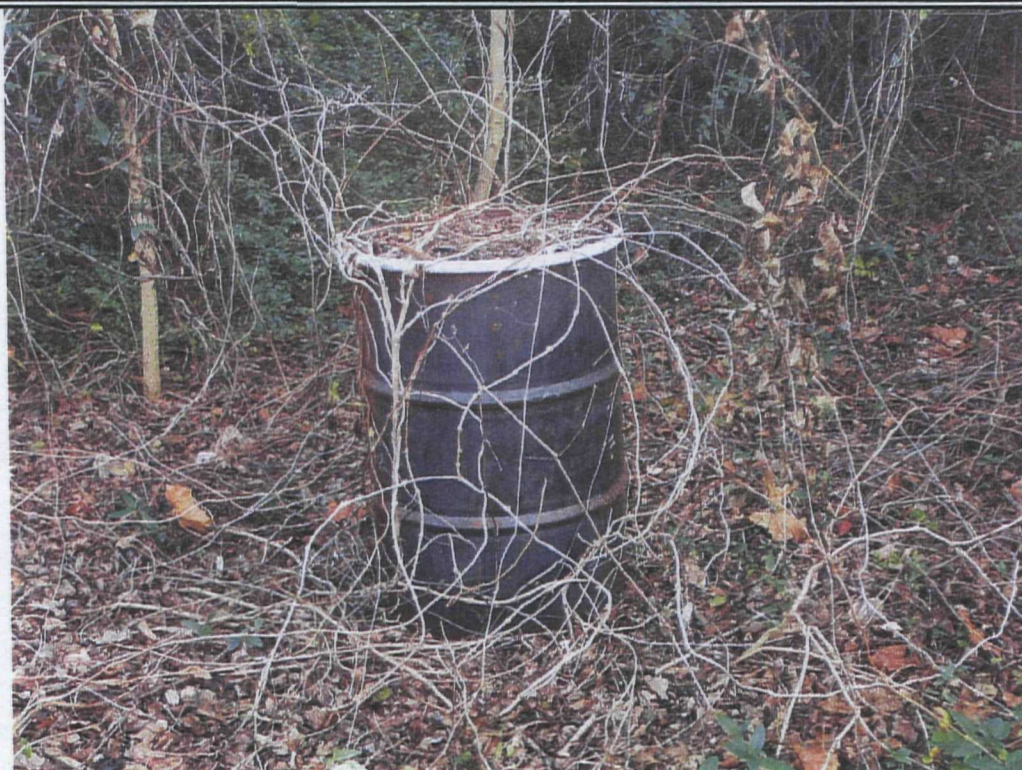
Photo	42 of 43	Date:	11/29/07	Site Name:	AZS Corporation		
Photographer:	Thomas J Brodell, QEP; HWMB			City:	Atlanta	County:	Fulton
Explanation:	Drum with solids not previously observed during 2007 CEI, possibly due to overgrowth. Drum located approximately 10 feet from well pictured in Photo # 41.					GPS:	Lat: 33.77454 Long: -84.42686

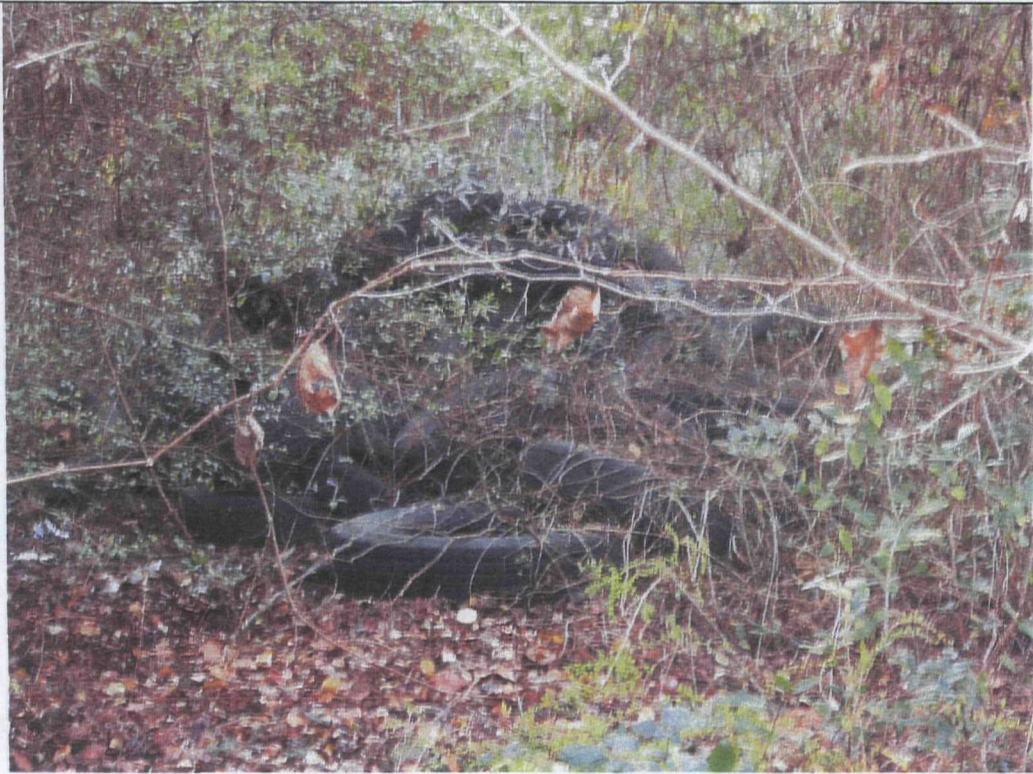
Photo	43 of 43	Date:	11/29/07	Site Name:	AZS Corporation		
Photographer:	Thomas J Brodell, QEP; HWMB			City:	Atlanta	County:	Fulton
Explanation:	Tire dump found in southeast corner of facility. During inspection, chickens were observed walking around and in front of tires. Green colored tents occupied by indigents faintly visible in background.

Open dumping was observed in several areas of the site. While most areas of the facility showed evidence of litter, several areas showed a small mound (less than one cubic yard) of domestic garbage, sometimes bagged, sometimes not. A tire dump was also observed near the southeastern corner of the property (see Photo # 23). Old industrial tanks, sumps and piping was also observed on-site (see Photo #s 09, 19 and 20). An old well casing was also observed on-site (see Photo #s 13 – 15).
